# Post-storage Transavia 737's loss of air data traced to unconnected pitot-static lines

By David Kaminski-Morrow | 23 March 2023

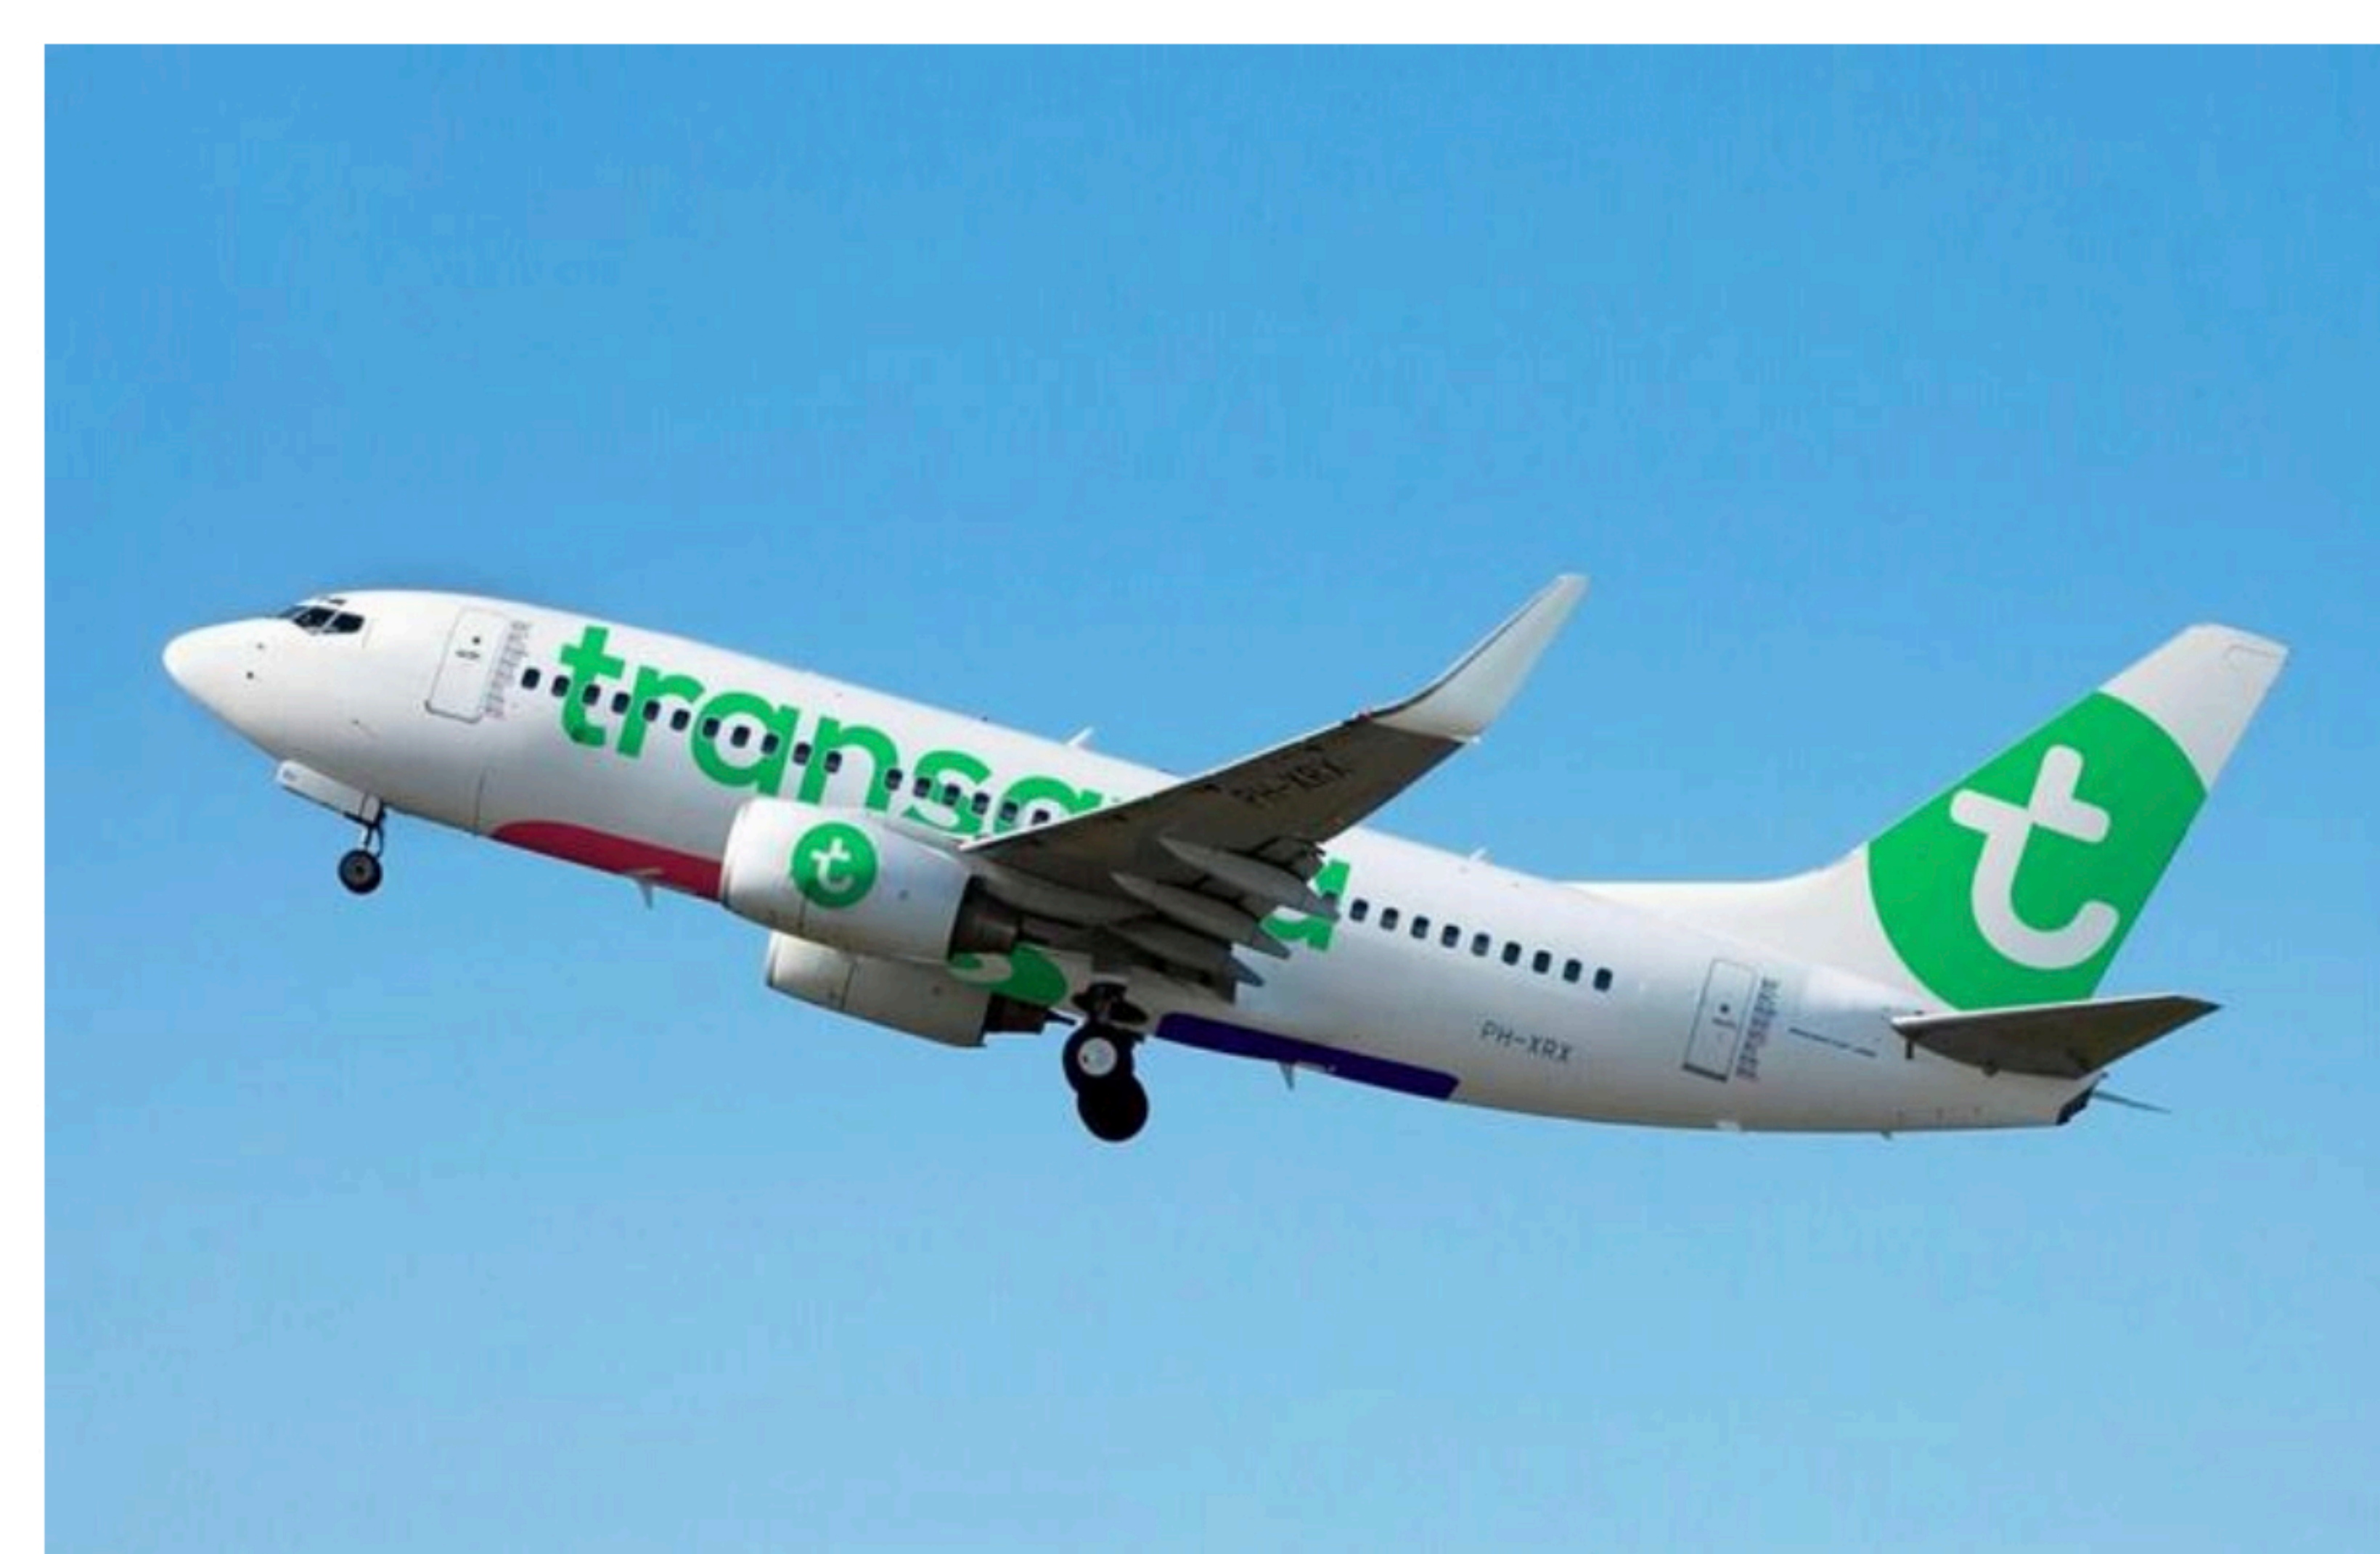
Pilots of the aircraft involved, PH-XXR, lost crucial airspeed and altitude data

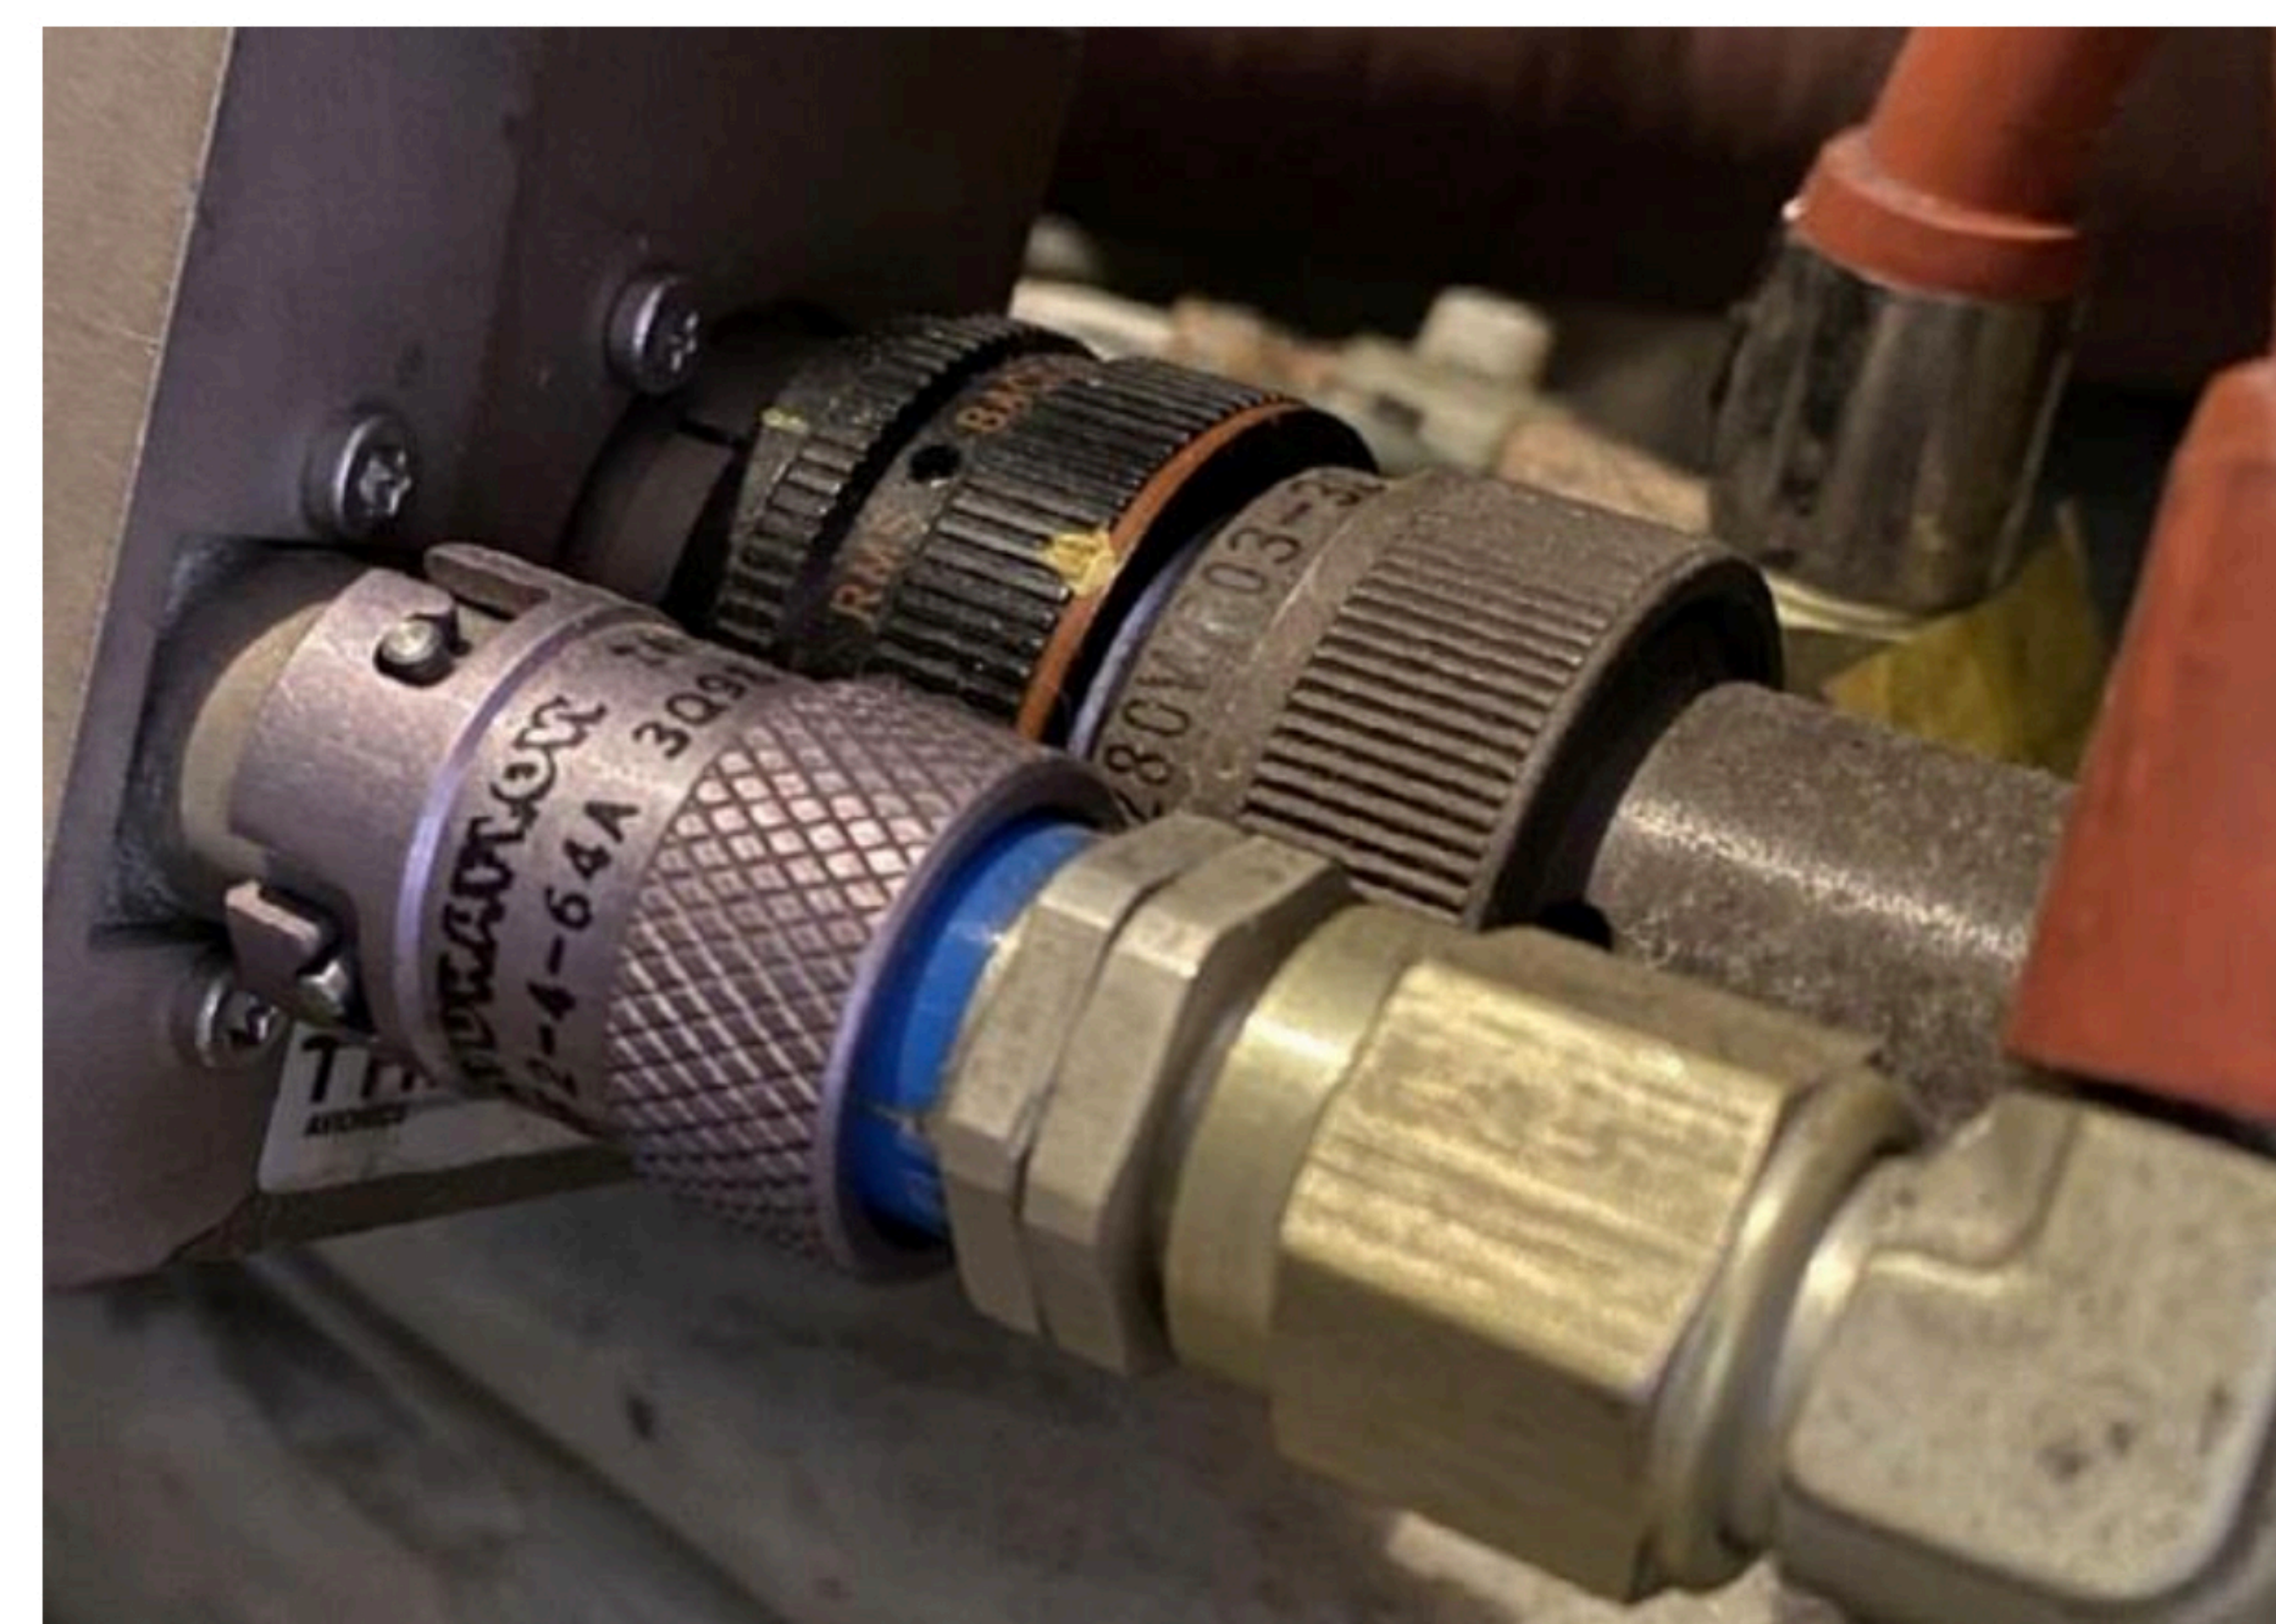
Maintenance personnel inspecting the pitot-static lines discovered three quick-disconnect fittings were not attached to their air-data modules – preventing the system from providing pressure-derived information to the cockpit.

But the safety board says the technicians performing the task “lost track” of who was responsible for the reconnection of the fittings. It states that the fittings are “very unlikely” to disconnect on their own, and that they were probably not connected correctly, or at all, after the flushing procedure.

Quick-disconnect fittings were not attached to the air-data modules
